# Litrak points out reasons for floods in Puchong

Blocked drains, narrow culvert and heavy rain caused late-evening deluge, says CEO

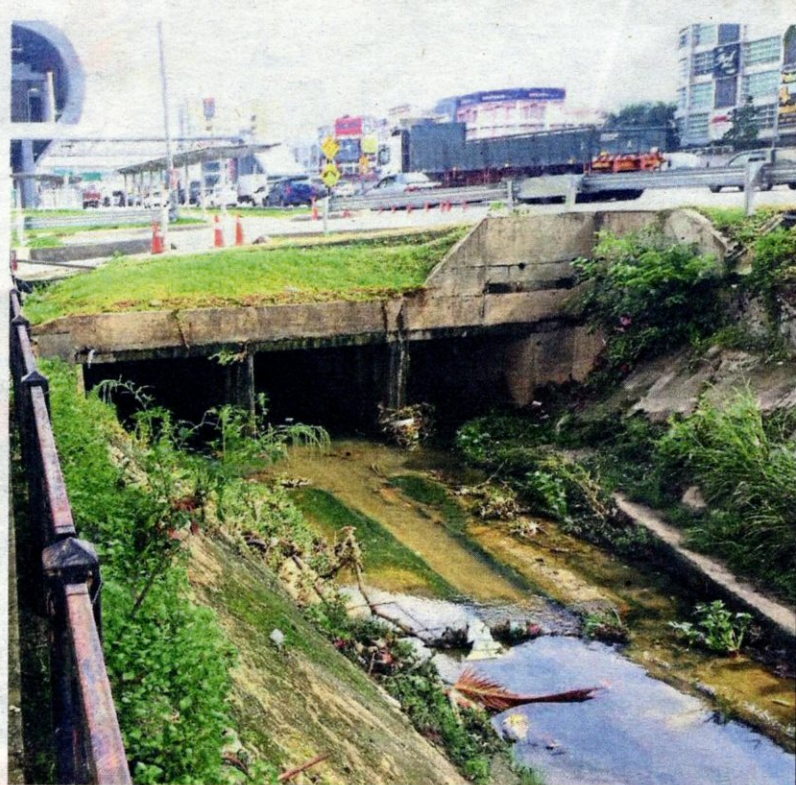
The second problem was that the monsoon drain used a triple-cell box culvert system.

Sazally said, unlike a single-cell box culvert system, the smaller divided cells were more prone to being clogged with mud and obstructing water flow.

Sazally says unlike a single-cell box culvert system, the triple-cell box culvert system is more prone to being clogged with mud, obstructing water flow.

He added that the remedy to this problem was to convert the culvert into a single-cell box culvert to improve water flow in the monsoon drain.

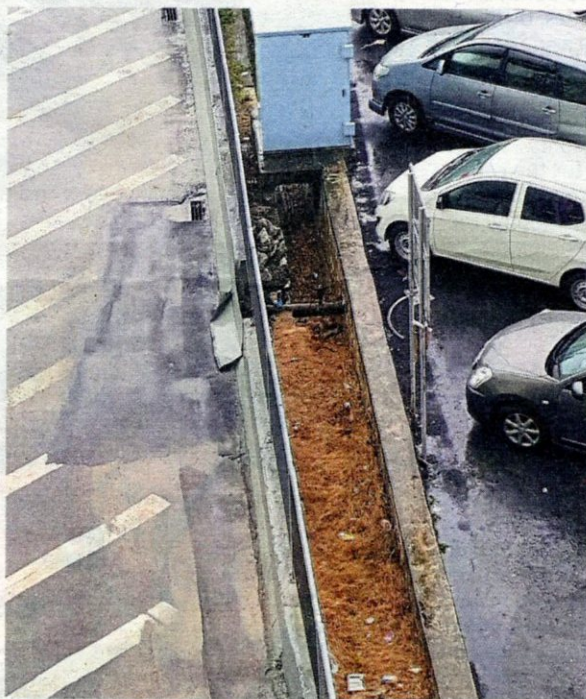
Water flow in front of the shoplots opposite IOI Mall is currently obstructed as the drains there were not cleared after the construction of the LRT station, added Sazally.

This meant that during abnormally heavy rain such as the one on Tuesday, water would overflow onto the highway.

The clogged drain next to the LDP.

Sazally suggested that the contractor for the LRT project contractors to clear and reinstate the drain near the shoplots.
